Survey No. F-8-119
Henry Baker Farmstead
Unionville, Maryland vicinity
Frederick County, Maryland

**Maryland Historical Trust
State Historic Sites Inventory Form**MARYLAND INVENTORY OF
HISTORIC PROPERTIES

historic Henry Baker Farmstead

7.1 Description

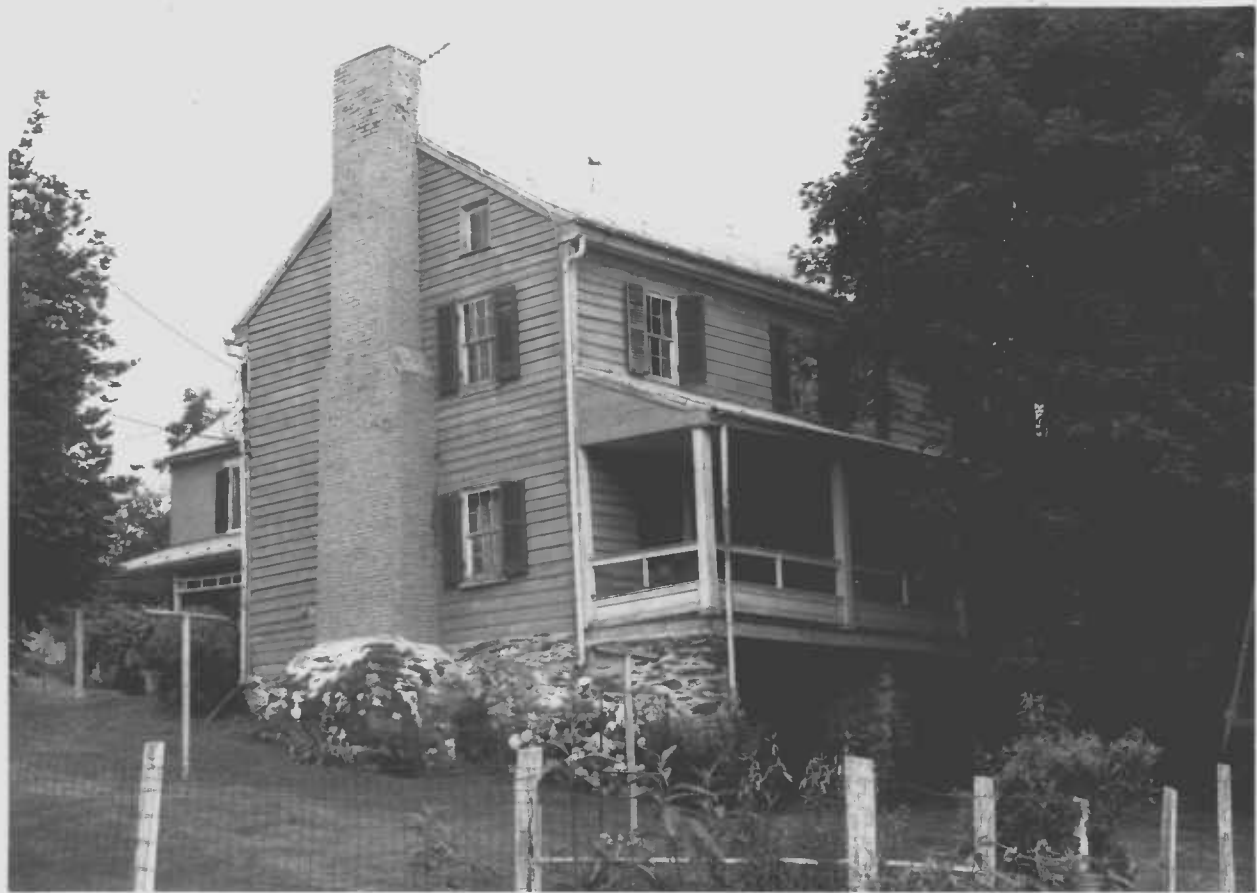
1/11

East elevation

The dwelling house has two sections, one a two-story log building with four bays facing east and a two-story brick ell extending west from the northwest corner of the log section. The log section is covered with clapboard siding and has a one-story porch extending across the width of the elevation. The topography on the east side of the house slopes away, exposing the stone foundation of the house and the porch and leaving storage niches under the porch. The access door to the cellar is under the porch in the southernmost niche. The porch has square columns and a balustrade with paneled bases. The log section has exterior end chimneys with a partially exposed stone base on the south chimney. The facade has two doorways in the center bays, one with a bullnose surround and the other with plain architraves. The windows are 6/6 and have louvered shutters. Square attic windows with 2/2 sash flank the chimneys. An extra bay appears to have been added on the south end, with a corresponding relocation of the chimney. The date of this addition has not been determined, but probably took place in the second quarter of the 19th century. The standing seam metal roof has a box cornice in the log section.

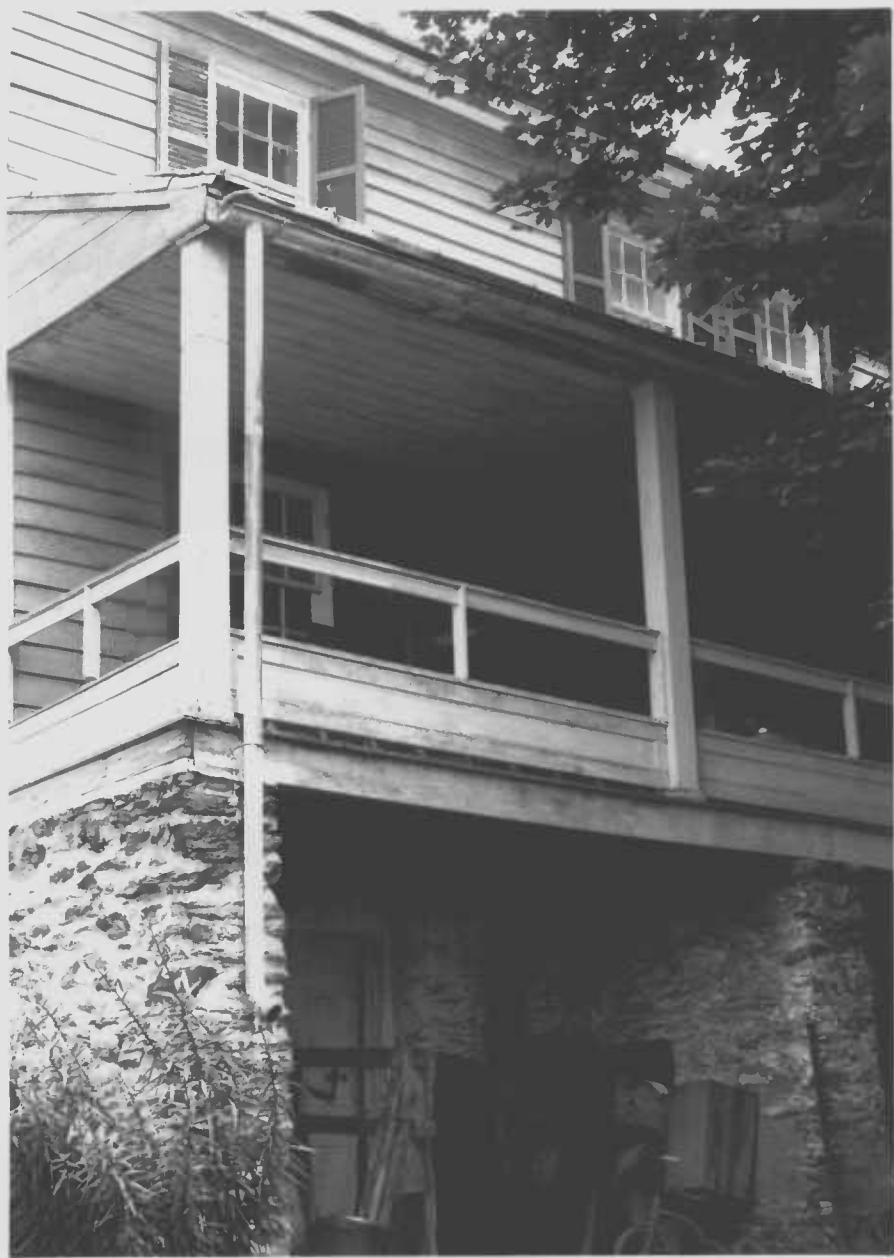
2/11

East elevation detail

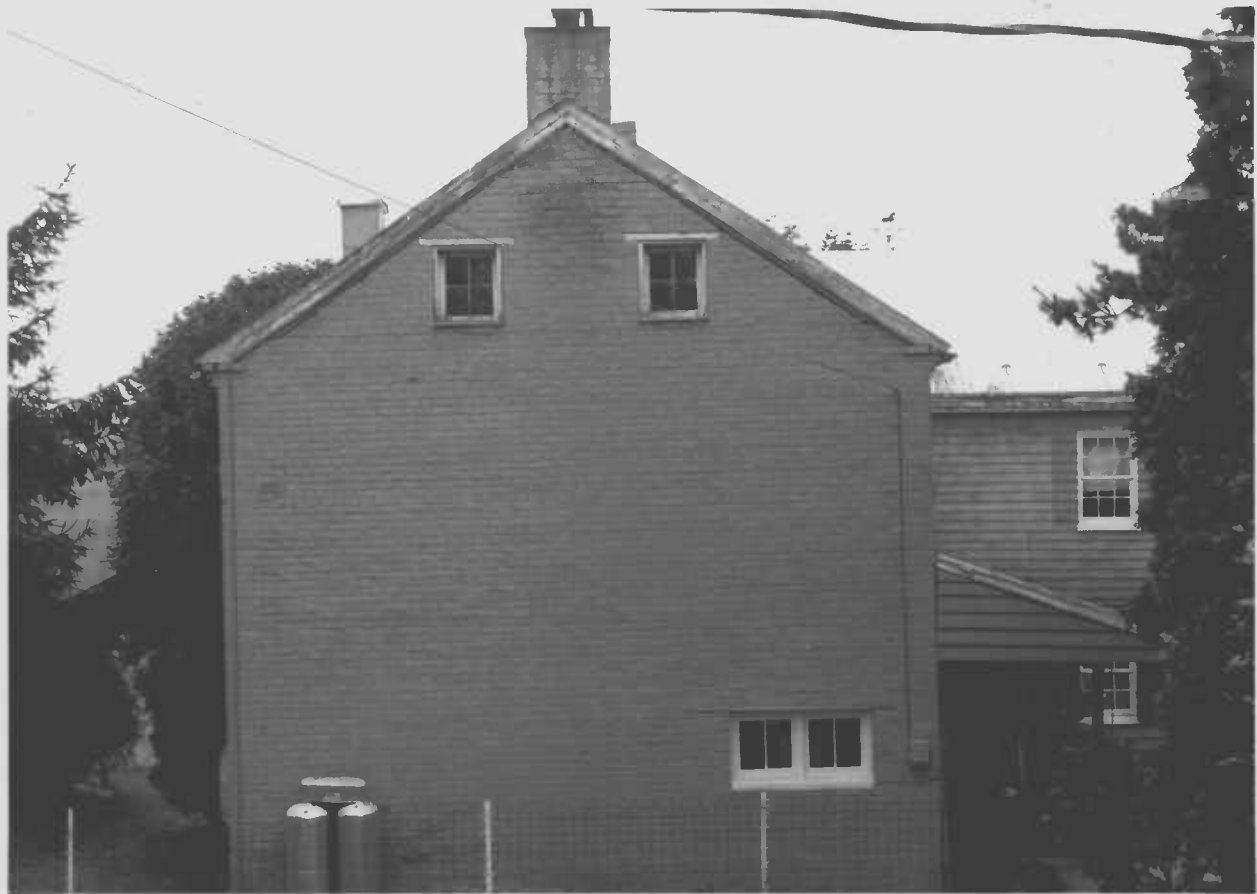
3/11

West elevation

The brick ell is laid in 6-course American bond and contains two rooms on both levels. The window and door openings have plain wood lintels and corner blocks. The sash is 6/6. The cornice is corbelled and the roof is an extension of the standing seam metal roof of the log section. A one-story open porch is located on the south side of the ell.

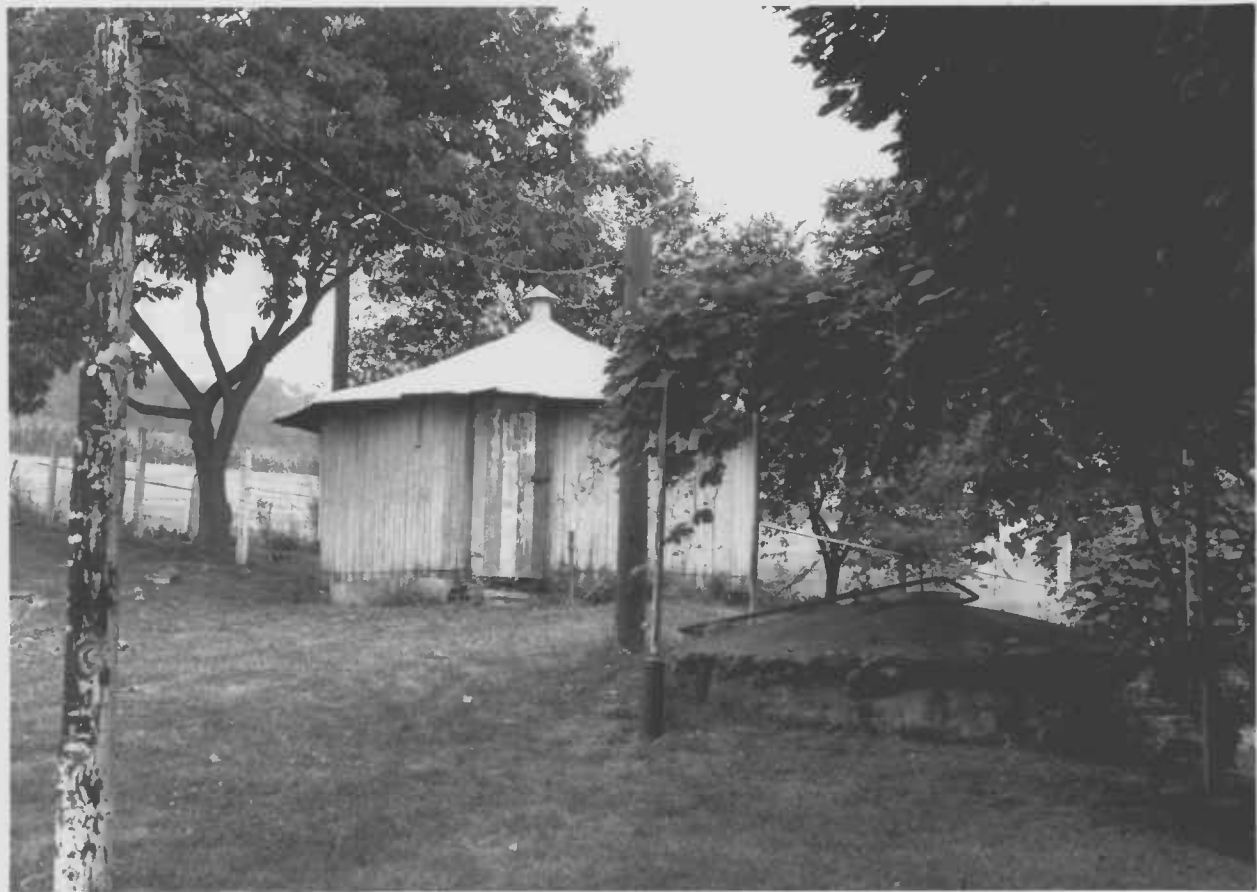
4/11

Chicken House #1, view from east; Cistern
in right foreground

Cistern: The cistern is located south of the Brooder House #1. It is a low brick-based, circular structure capped with concrete. A grape arbor stands above the cistern. The windmill described later pumped water from the spring east of the house to the cistern.

Chicken house #1: A small, wood "dog house" size structure located east of Brooder #2. The structure was acquired from another property but has never been used in the Baker Farmstead. Its date is unknown.

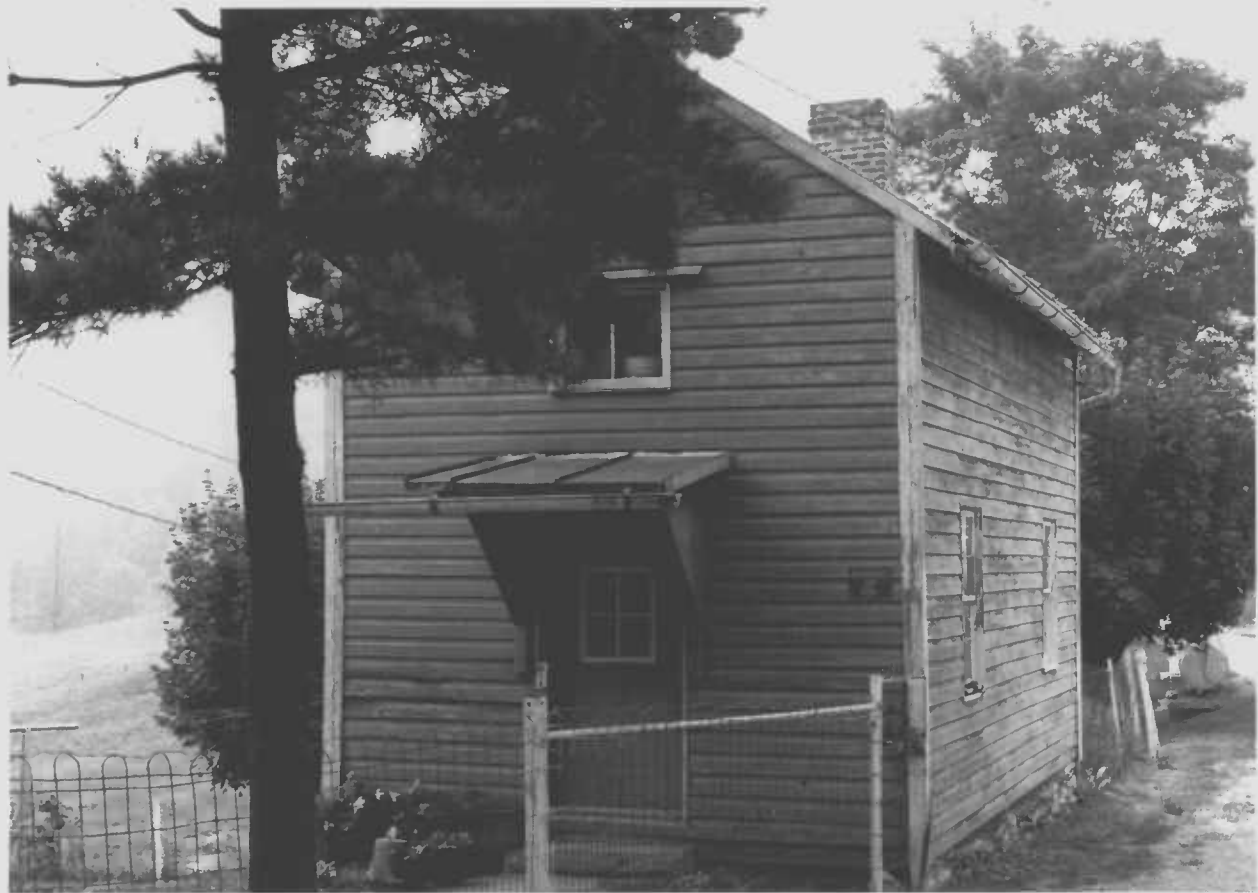
5/11

Summer kitchen, north elevation

Summer kitchen: A frame, two-story rectangular building of about 1875, the summer kitchen has german siding and an interior end brick chimney on the south end gable. A single door opens in the north gable end. The east and west elevations have two window bays each with 6/6 sash. The foundation is stone and the roof is standing seam metal. The door is vertical flush boards with a 2/2 glazed upper panel. A shed canopy extends over the door. A bell is attached to the north gable peak.

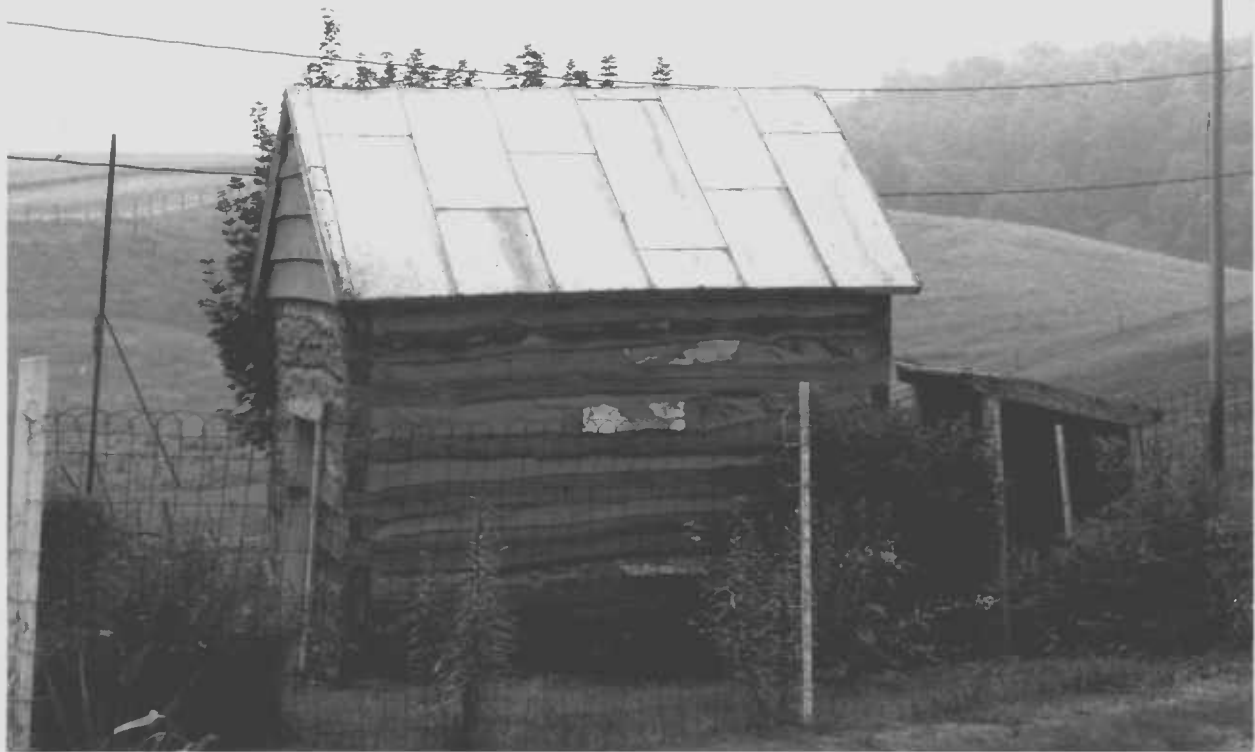
6/11

Smokehouse and privy, west elevations

Smokehouse: The log smokehouse may have been built in the second quarter of the 19th century based on the condition of the logs. It has a rectangular form with a gable roof covered with standing seam metal and frame gables with clapboard siding. The door is on the north gable end and is made with vertical flush boards.

Privy: The privy is located south of the smokehouse and is basically square in plan. It has vertical board siding and a shed standing seam metal roof. The single door is on the north elevation.

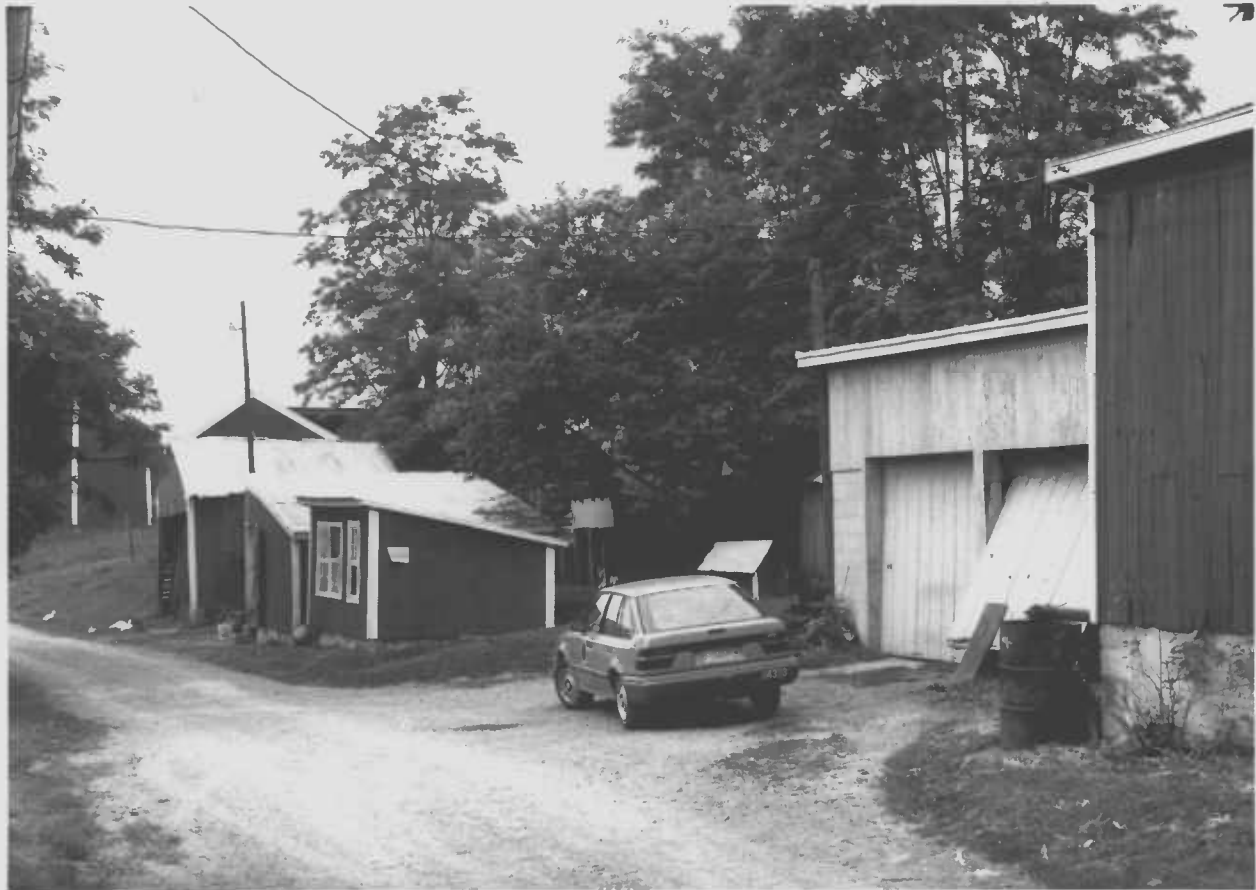
7/11

Garage and chicken houses, view from
north

Wood shed: A frame building with a concrete block base and tongue-and-groove siding, the wood shed was probably built in the last quarter of the 19th century or first quarter of the 20th century. It has a corrugated metal shed roof and doors on the east and north elevations. An open shed is attached to the west side. A non-contributing concrete block garage built in the 1950's adjoins the wood shed on the south.

Chicken house #2: A shed-roofed frame structure with vertical tongue-and-groove siding, the structure has several windows on the east elevation, including 6/6 and 4/1. The foundation is concrete block. The structure may date from about 1910.

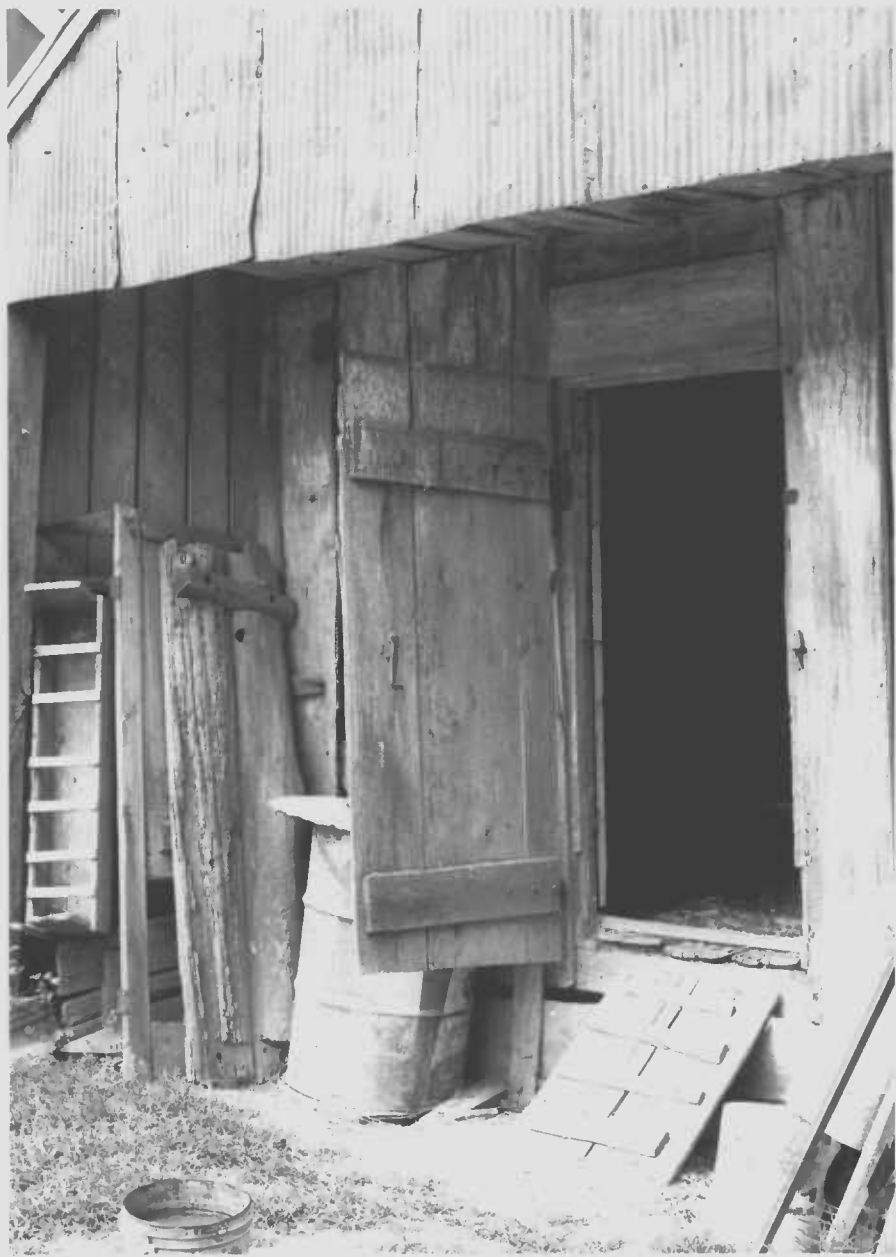
8/11

Goose/duck Shed detail, east elevation

Chicken/duck house: Originally a chicken house, this wood frame structure dates from the last quarter of the 19th century. It has a gable roof and vertical siding. The front wall of the east elevation is recessed with the gable forming an overhang. The single doorway is in the center of the recessed wall. The roof was originally shingled and is now covered with corrugated metal, as are the north, south and west elevations.

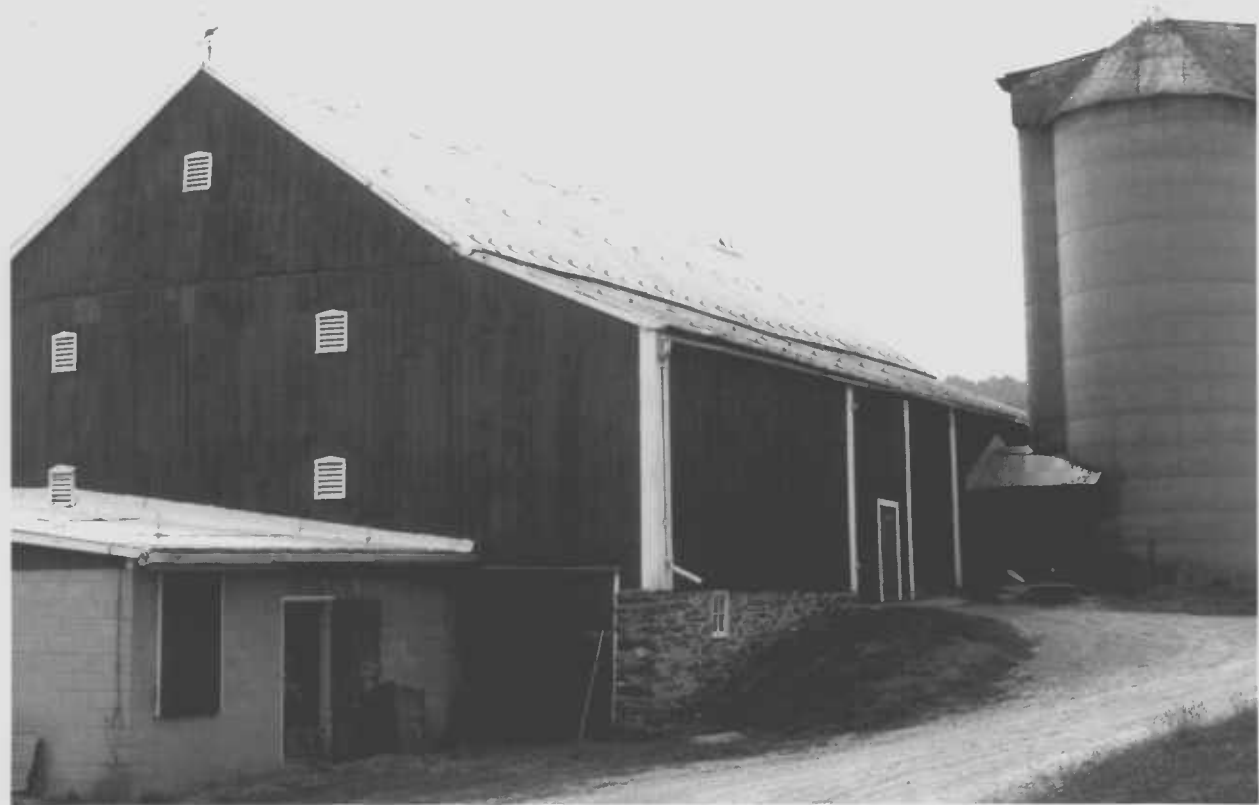
9/11

Bank barn, northwest corner view

Bank barn: The barn appears to date from the third or fourth quarter of the 19th century. It has a stone foundation and hand-hewn frame upper structure. The vertical siding is machine-milled and probably dates from nearer 1900. The roof is both corrugated metal and standing seam metal. The standing seam portion on the west slope of the gable roof covers wood shingles. The plan is a typical single drive floor upper level with flanking hay mows over a two-aisle feeding level. A concrete block milking parlor built about 1945 encloses the south end of the forebay. Adjacent to the milking parlor is a separate concrete block milk house of about the same date. The forebay remains mostly intact. Two metal and concrete block loafing sheds and a heifer shed of the 1950's are located adjoining and east of the barn; these do not contribute to the complex. A concrete silo located at the southwest corner of the barn is also non-contributing due to recent construction.

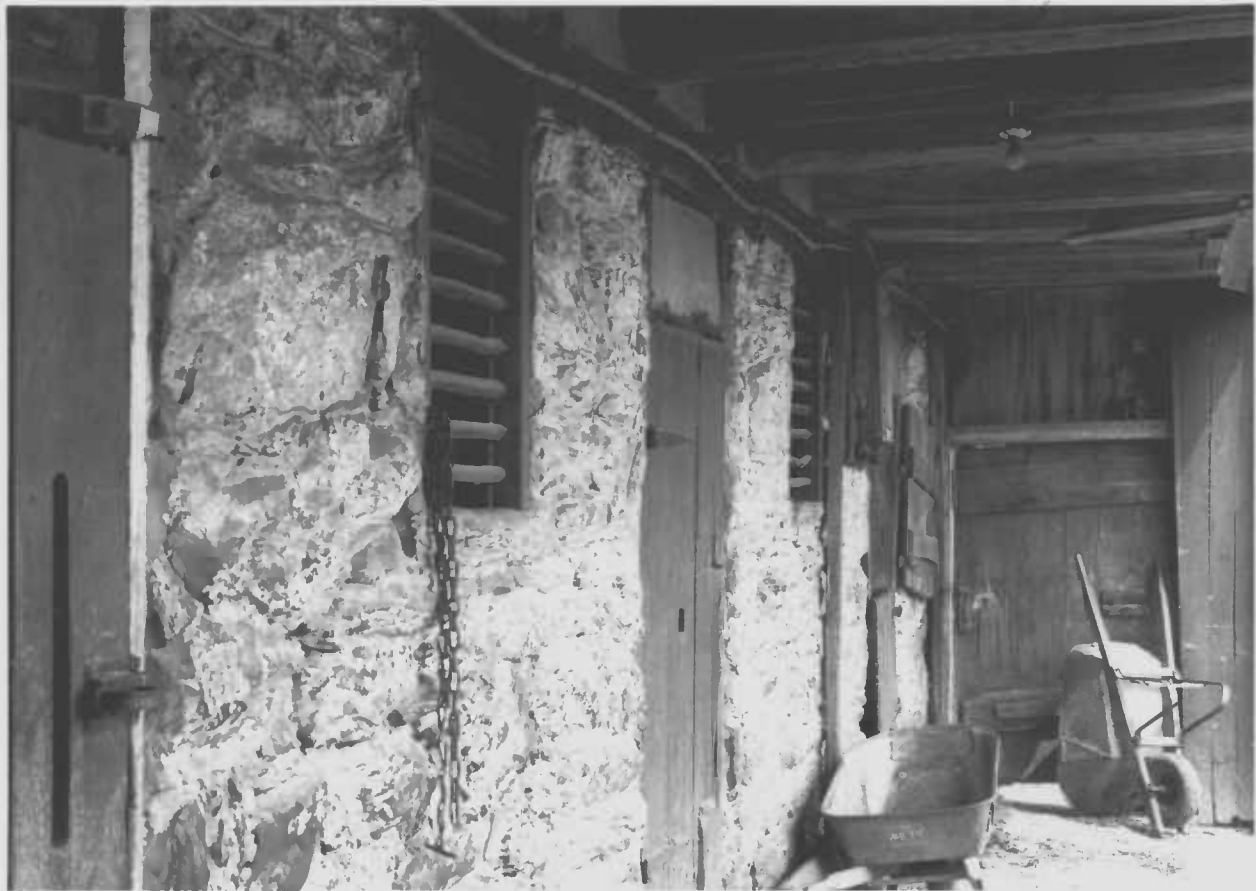
10/11

Bank barn, fore bay detail, east elevation

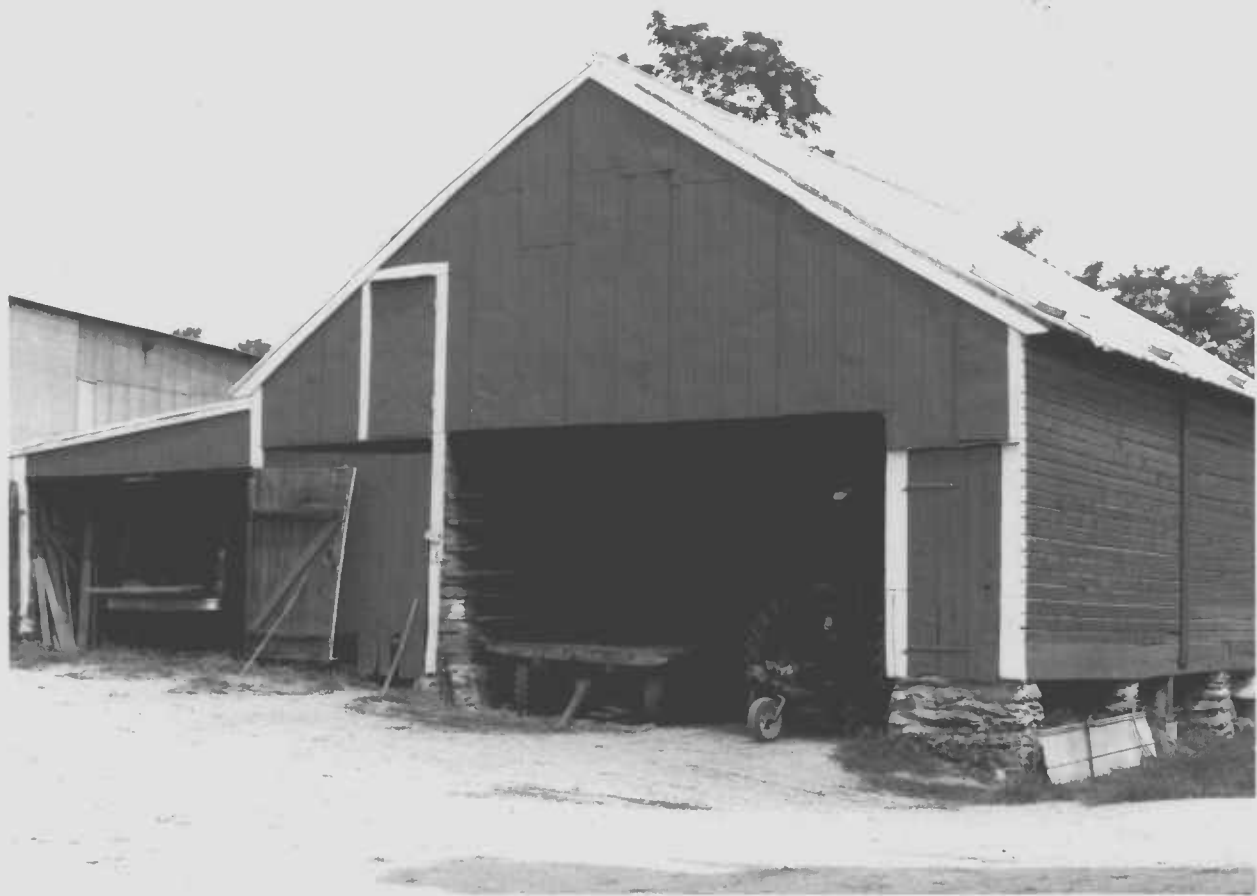
11/11

Corn crib/wagon shed, south elevation

Pull-through corncrib/wagon shed: The double-sided granary is located northwest of the barn and has a stone foundation, vertical and horizontal siding and a corrugated metal roof. An attached shed on the west side houses equipment. Metal siding covers the north and south gable ends of the corncrib. It probably dates from the last quarter of the 19th century.
